**POVERTY POINT LIMESTONE  
QUARRY SLOPE STABILITY  
ASSESSMENT AND DESIGN  
GUIDELINES**

Submitted to: HOLCIM (US) Inc.

May 19, 2006

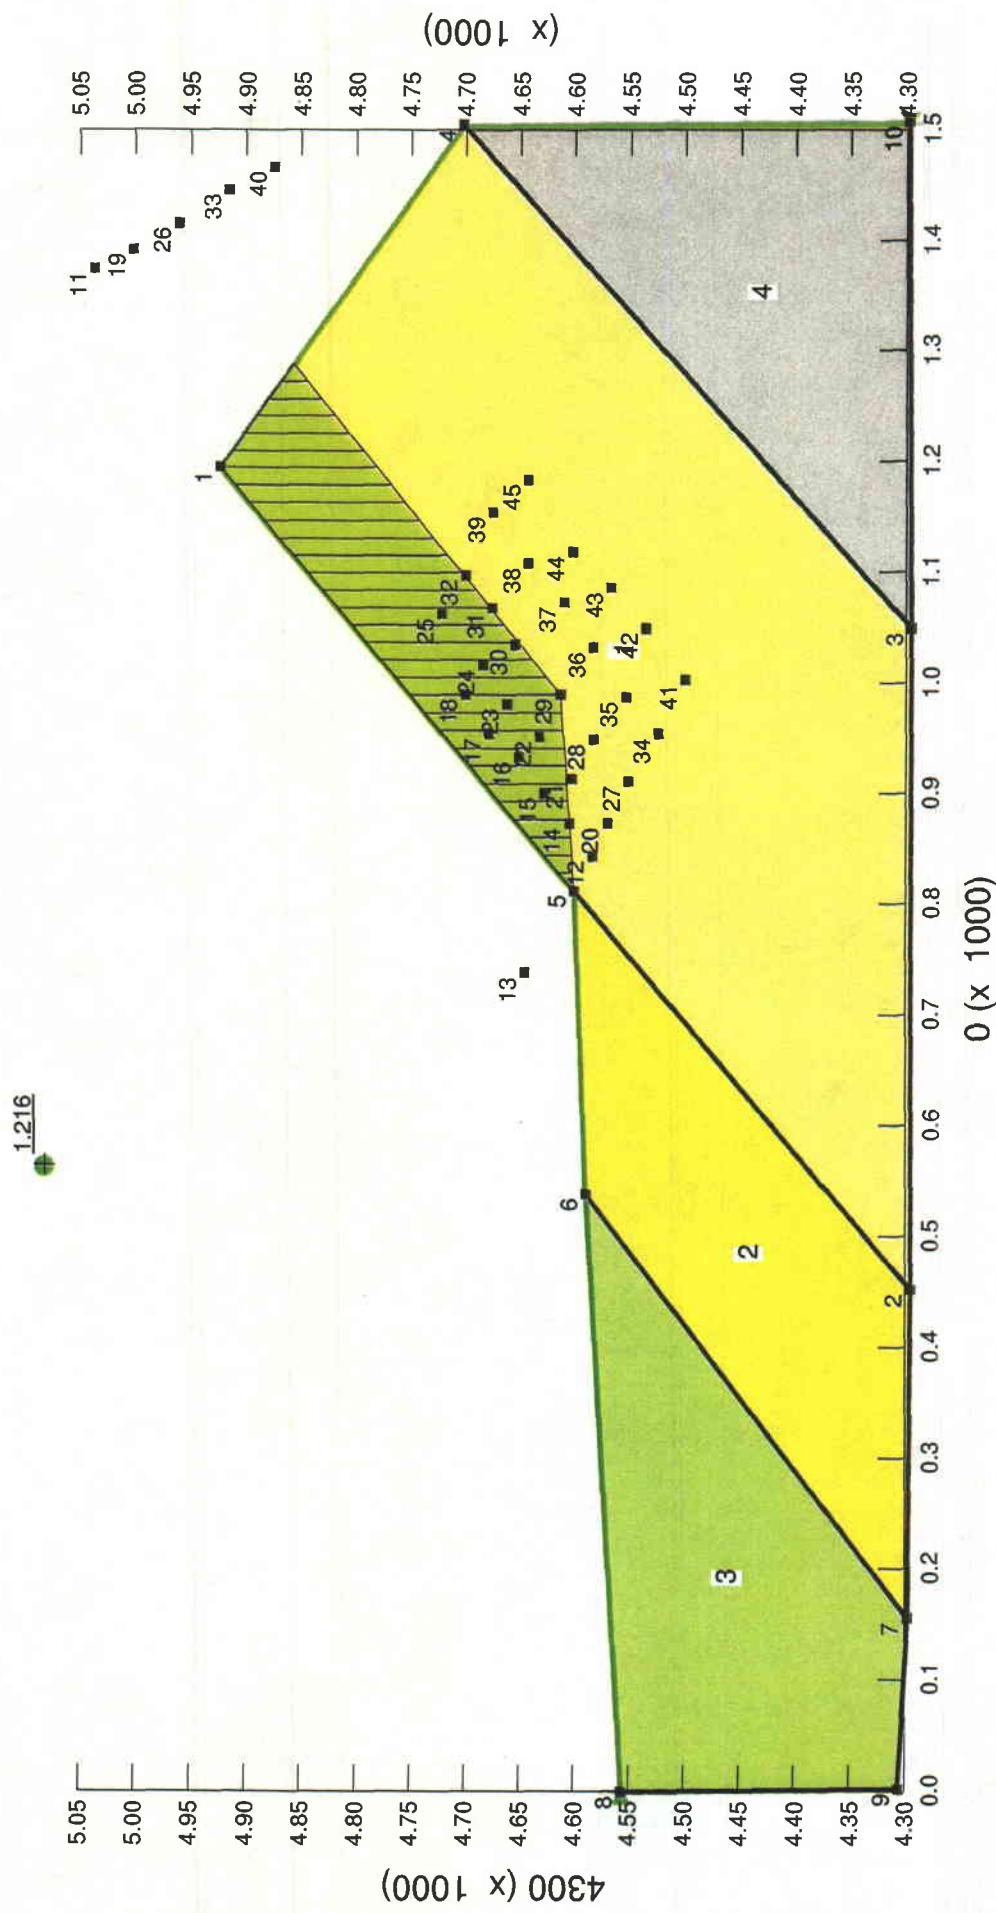
Name: 35 degrees disturbed.gsz

Material #: 1  
Description: Blast Disturbed Limestone  
Model: ShearNormalFn  
Wt: 100  
Strength Fn: 1  
Material #: 2  
Description: Undisturbed Limestone  
Model: ShearNormalFn  
Wt: 100  
Strength Fn: 2

Material #: 3  
Description: Alluvium  
Model: MohrCoulomb  
Wt: 100  
Cohesion: 0  
Phi: 45  
Material #: 4  
Description: Bedrock  
Model: Bedrock
